# Owyhee Dairy Complaint Investigation Report

By Emily Montague

May 22, 2019

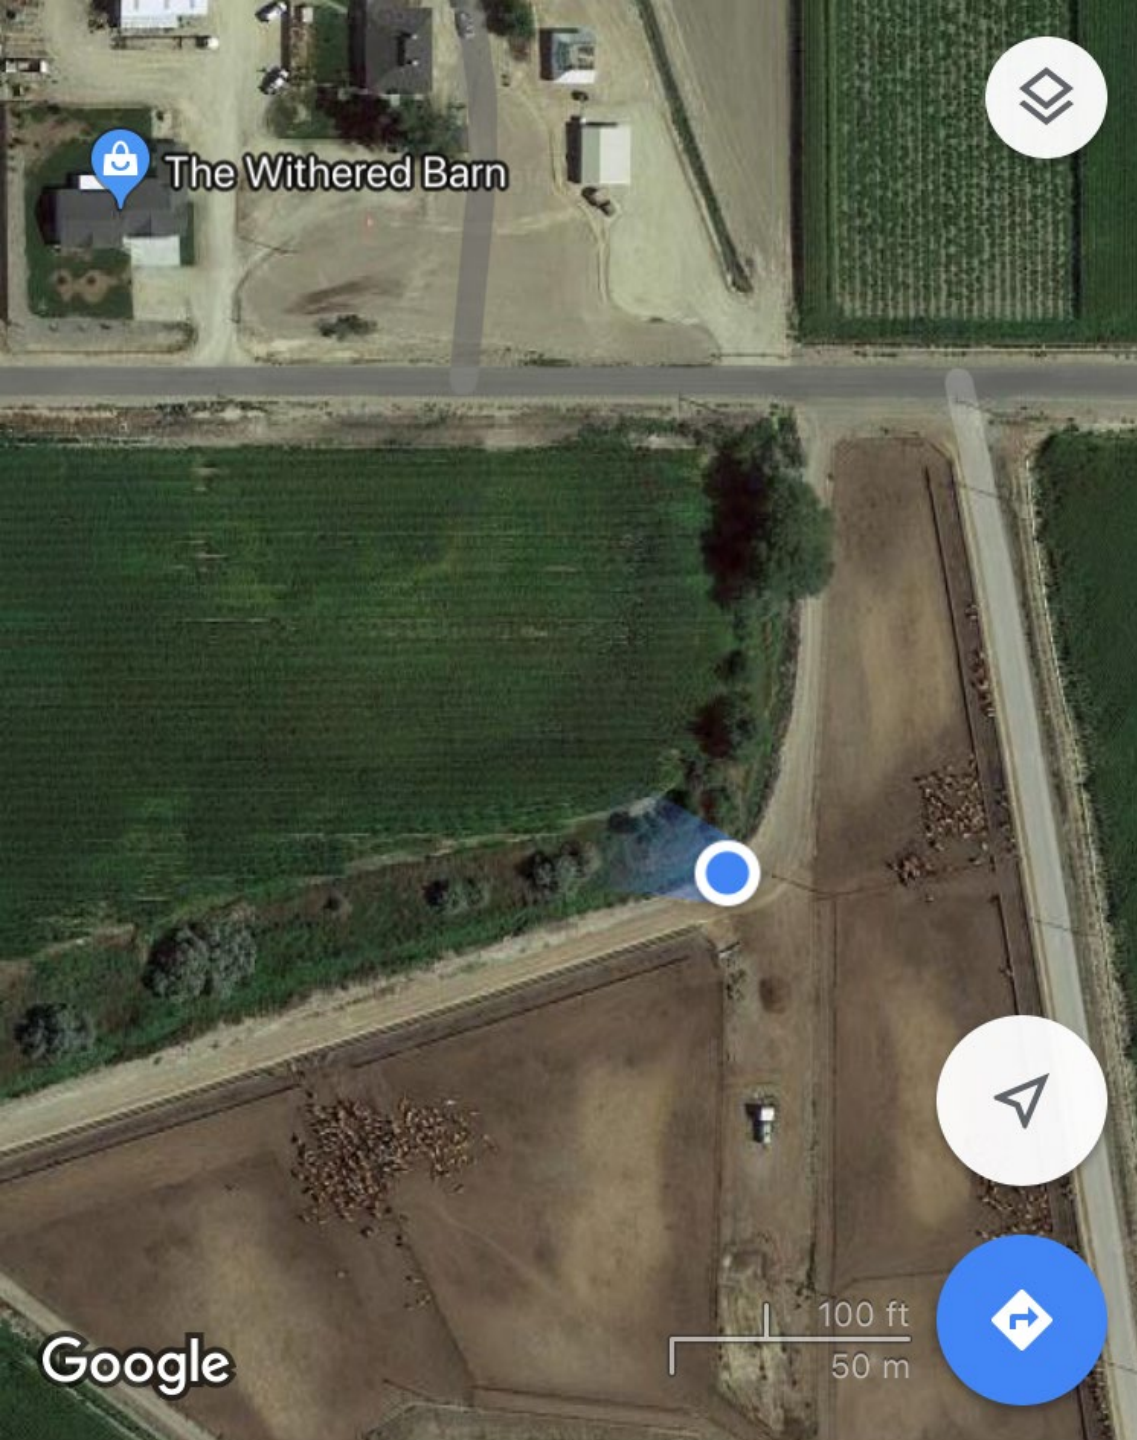
Google Maps aerial photograph shows placement of where the pipe head coming out of the bank was observed in the ditch. Blue dot marks placement of where Inspector Montague was standing when the head of the capped pipe was observed on May 21, 2019.

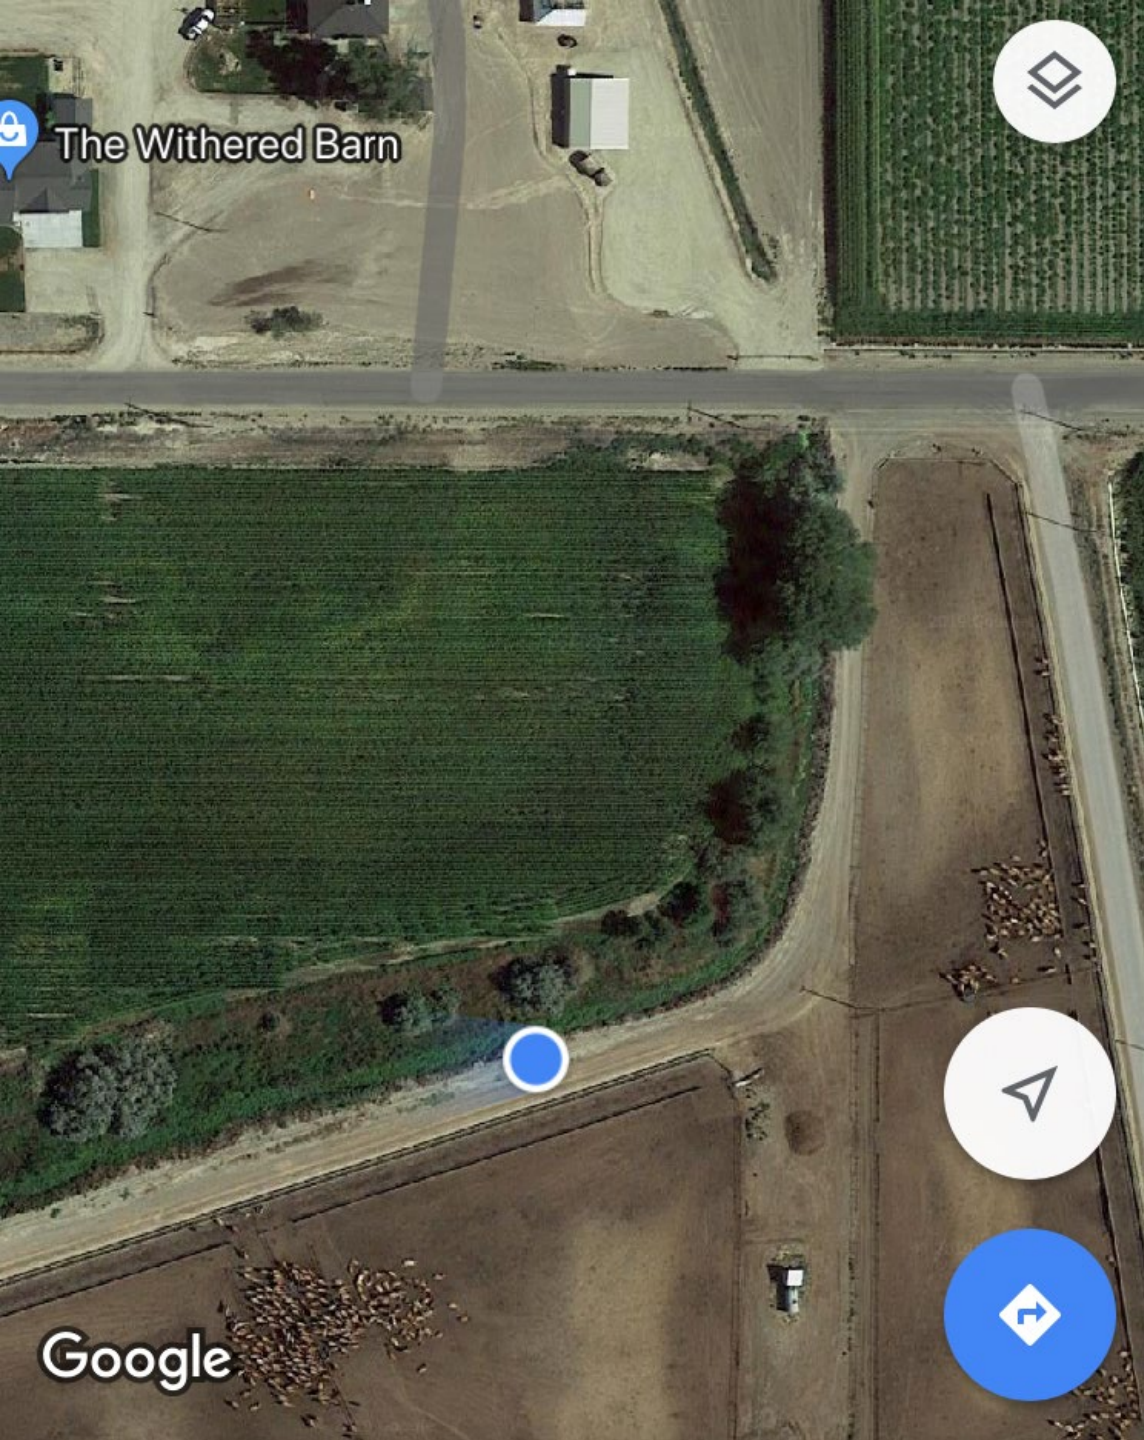
Google Maps aerial photograph shows placement of where second cut in bank was observed at Owyhee Dairy facility. Blue dot marks placement of where Inspector Montague was standing when the second cut in the bank was observed on May 21, 2019.

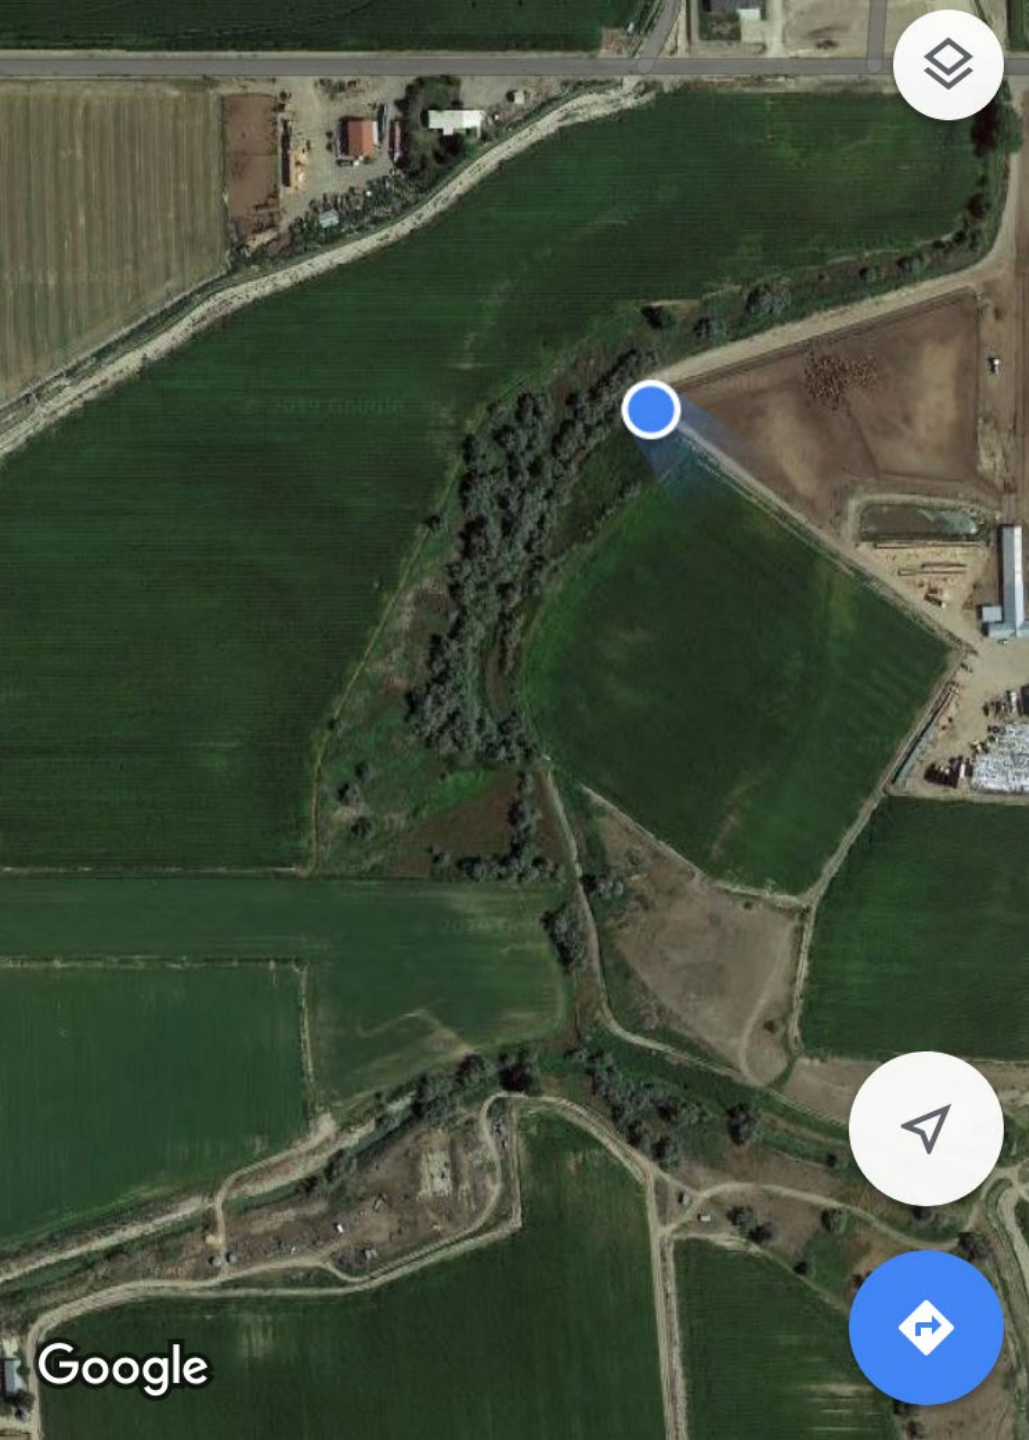
Google Maps aerial photograph shows placement of where third cut in bank was observed at Owyhee Dairy facility. Dirt and rubble was pushed into ditch at this location. Blue dot marks placement of where Inspector Montague was standing when the third cut in the bank was observed on May 21, 2019.

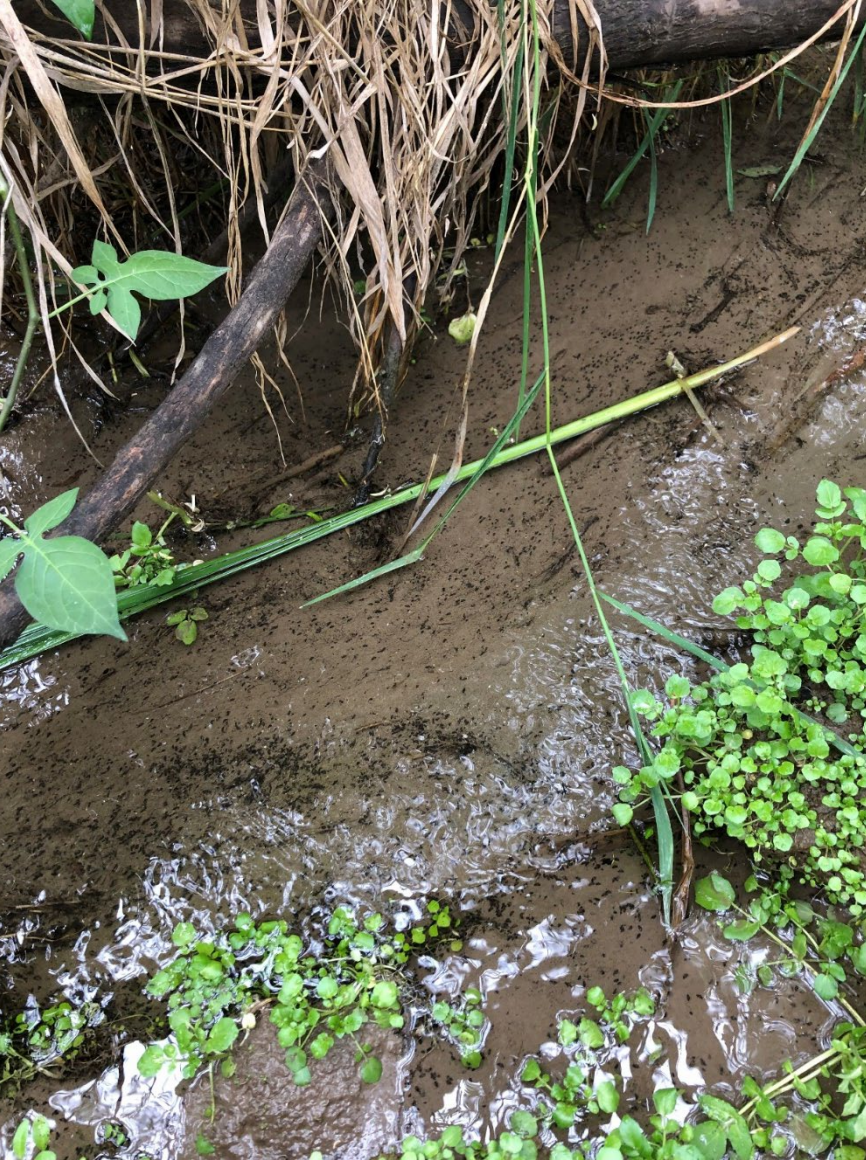
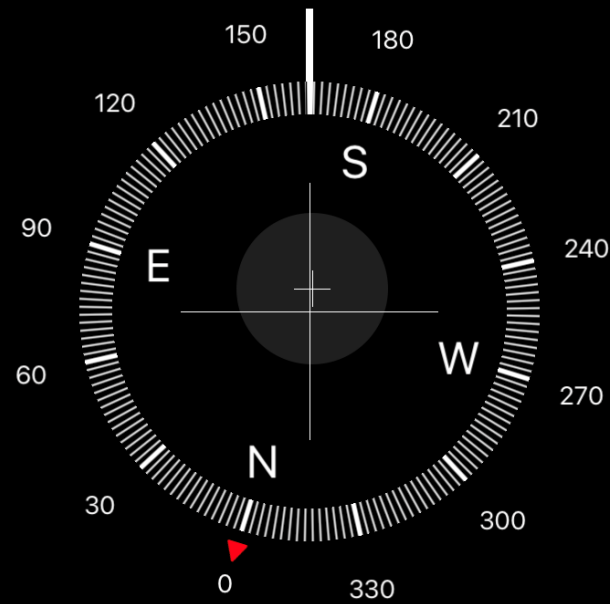
162° S

Photograph taken by Inspector Montague on May 21, 2019 facing 162 degrees shows clean water observed near spring that feeds to Town Ditch. Location was upstream from Town Ditch that borders Owyhee Dairy facility.

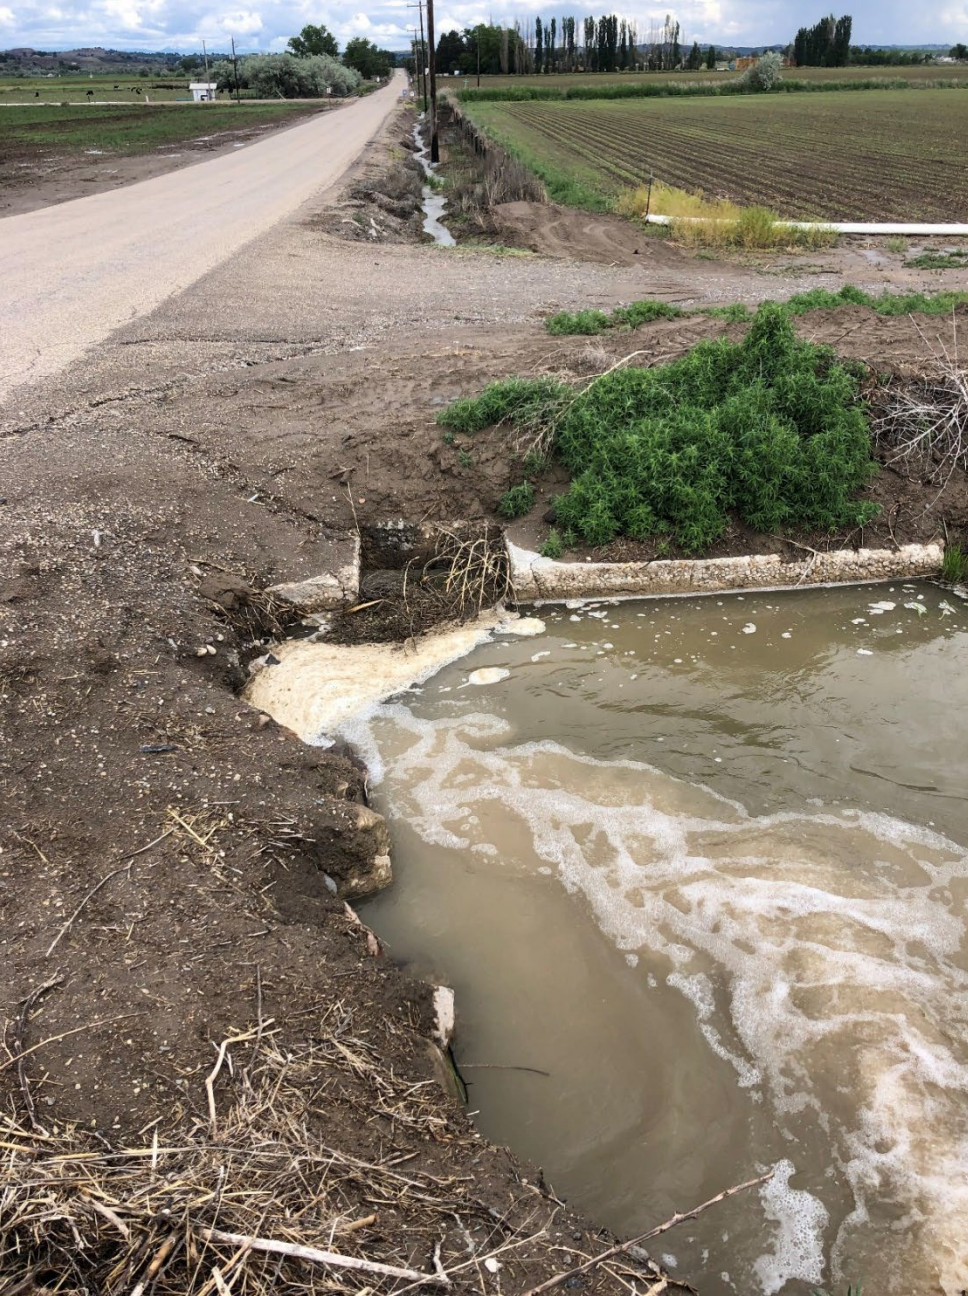
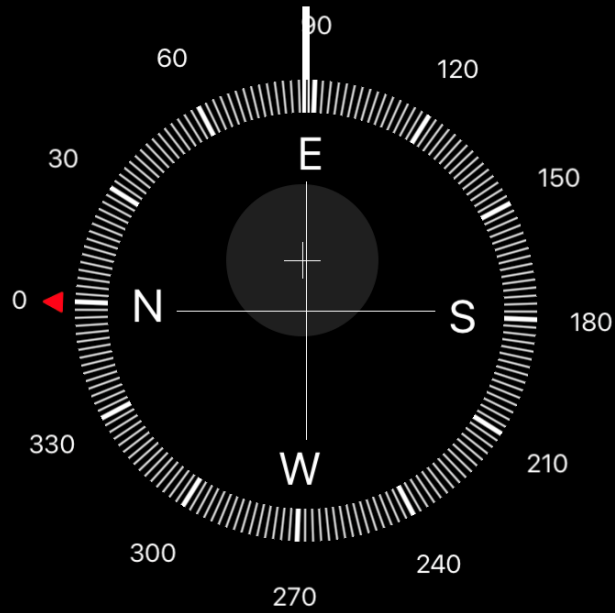
87° E

Photograph taken by Inspector Emily Montague on May 21, 2019 facing 87 degrees East shows where Town Ditch enters lateral that flows east towards drain that connects to Jump Creek.
